DCON Utility revision history

DCON Utility	Version 5.2.2
Release Date	Dec 20 2011

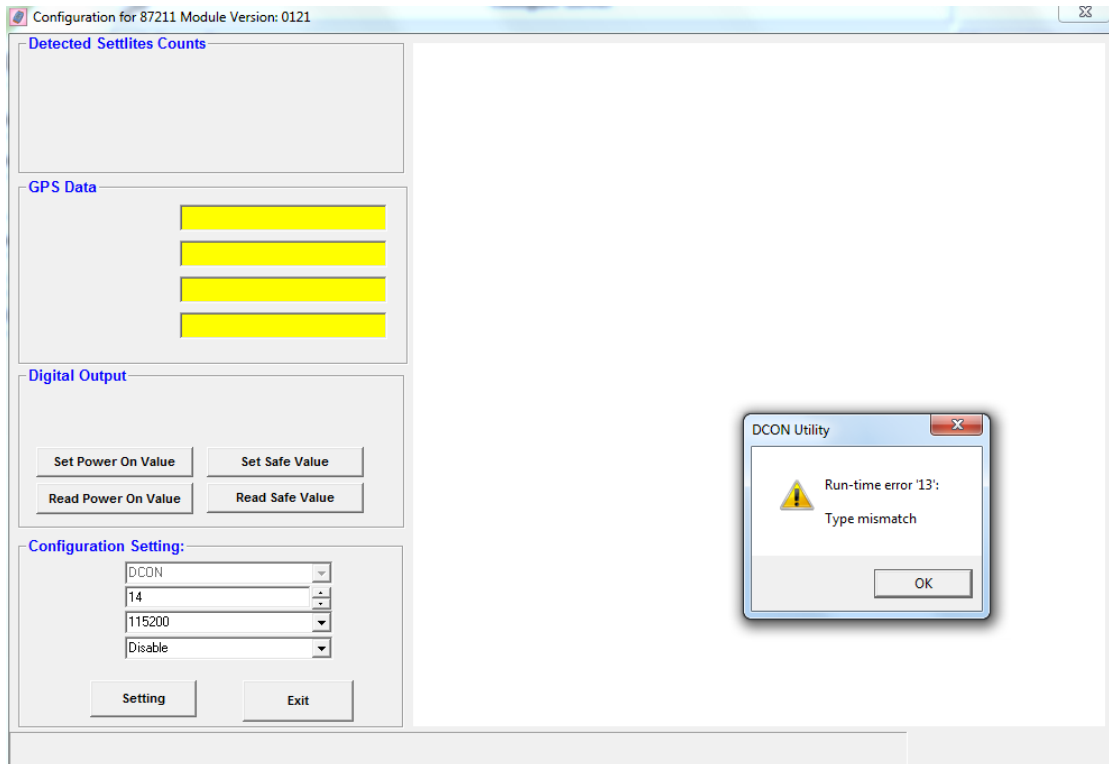
1. Click I-87211W form to cause "Run-time error 13" as below:

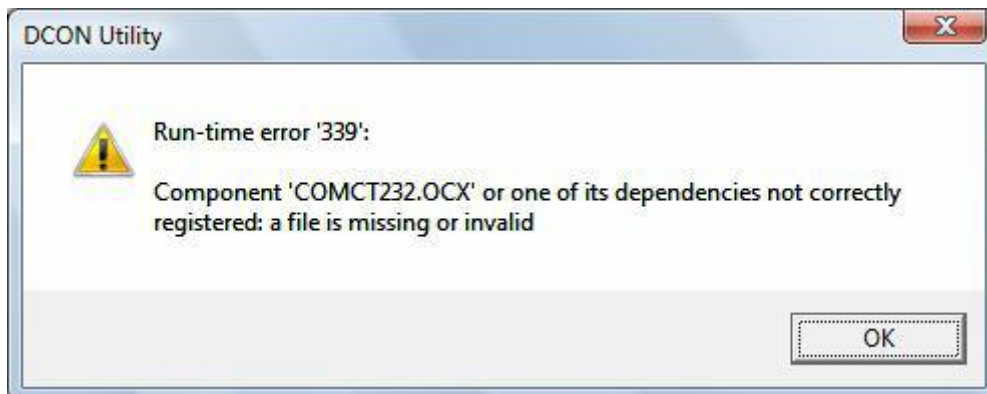
2. Add manifest function to avoid to abnormal install and run DCON Utility in Windows 7 and Vista , or it will cause ocx file fault (similar “Run-time error 339” as below). We recommend to install and run it using administrator account. If it appears , please refer FAQ_Run_time_error.pdf to solve it

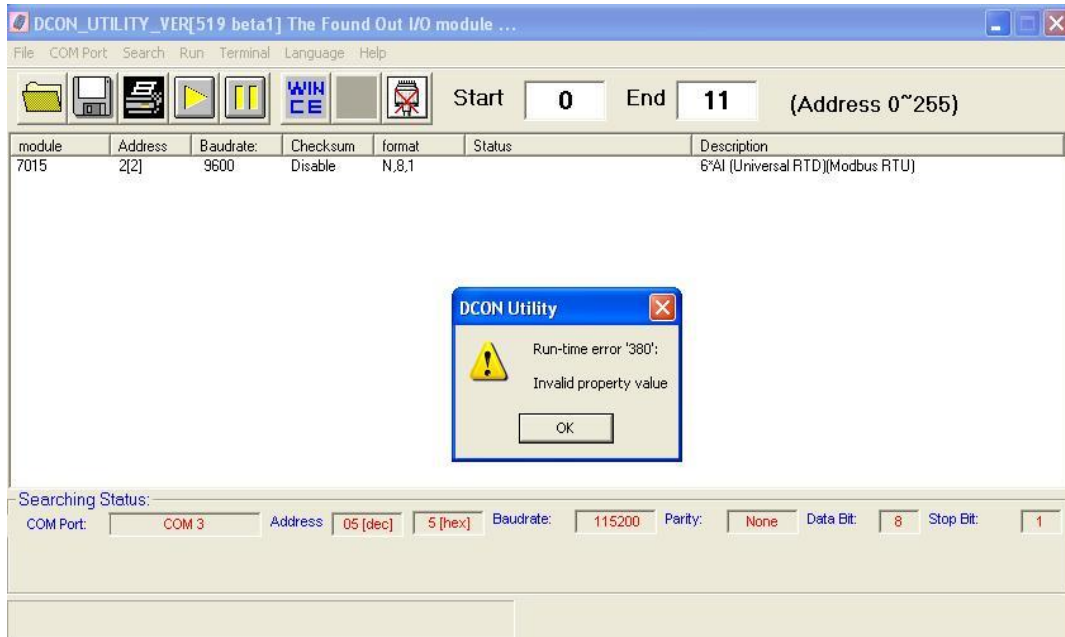
3. Click old M-7015 firmware version (Before version B202) to cause “Run-time error 380” as below

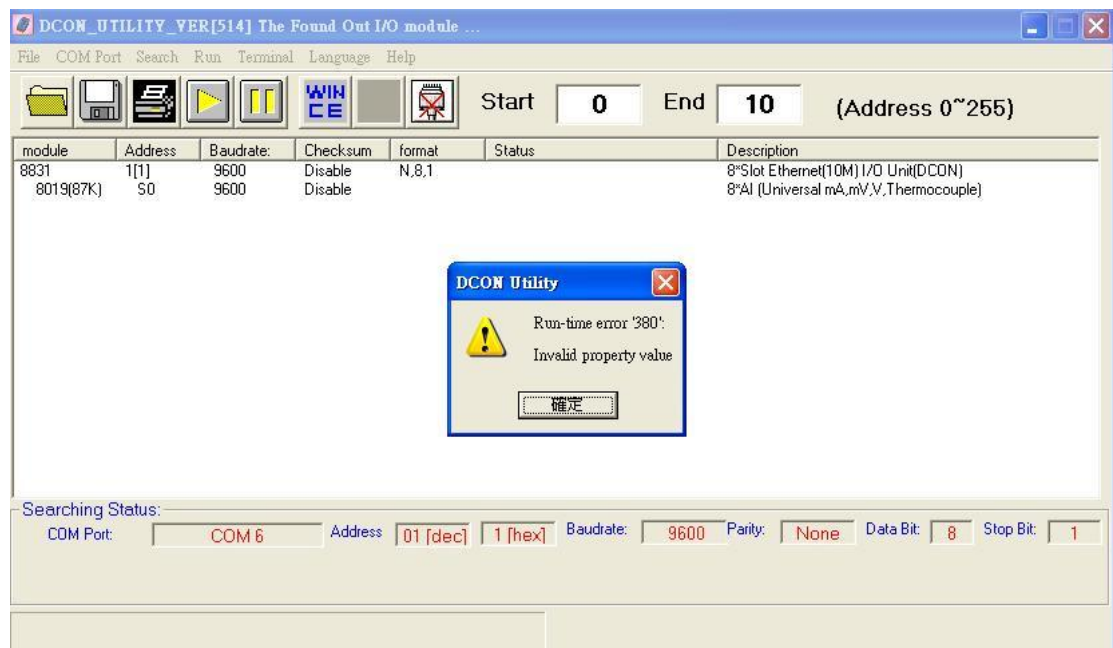
4. When using DCON firmware ,click 8019(87K) to cause “Run-time error 380” as below

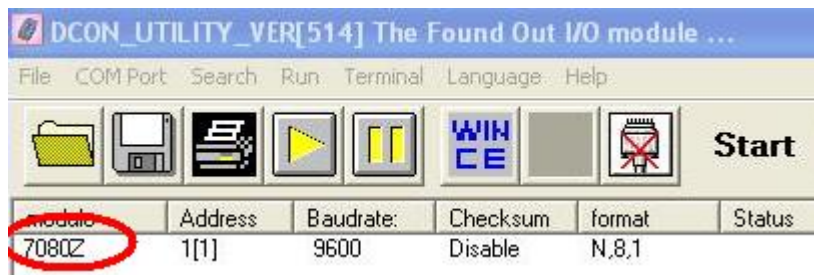
1. When DCON Utility searches M-7080BD ,it shows "7080Z"

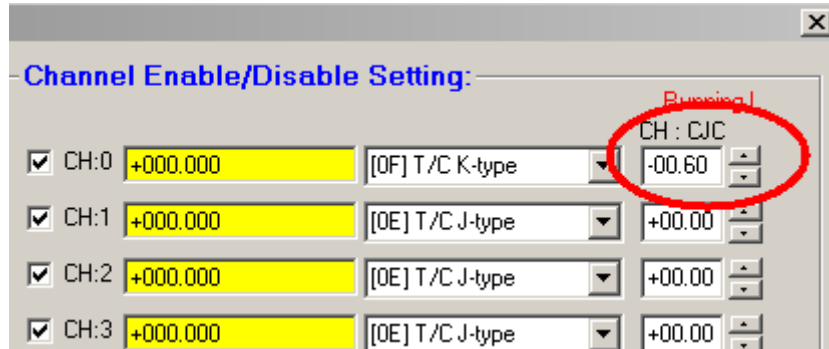
2. M-7018 can't set channel CJC function

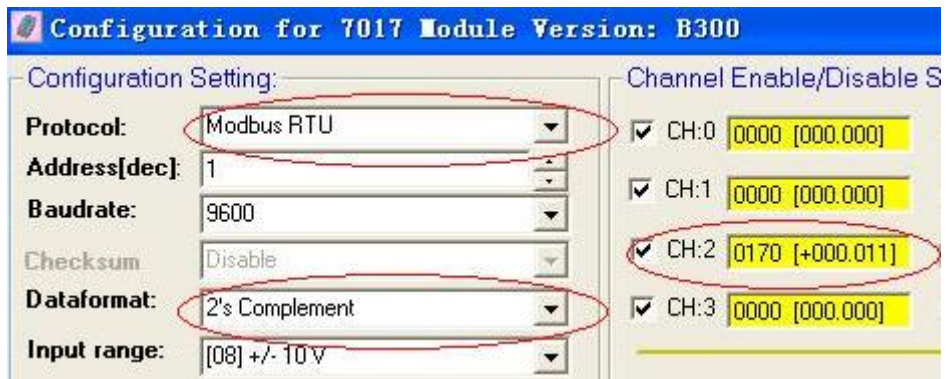
3. I-7017 and M-7017 show wrong AI value in Hex data format
